PCA-based Localization of Pathology on Heritage Building Masonry

Abstract: *Laser scanning is one of the most common techniques for the geometric documentation of historical buildings. The last decades, laser scanning has replaced or complemented traditional topographic methods to a significant degree. The advantages of laser scanning that led to its high appreciation of the scientific community is that it is a fast method of geometric documentation that combines the accuracy of topographic and the wholeness of photogrammetric methods. The data that a laser scanner provides to the user is a large set of XYZ coordinates that is called point cloud. The point cloud needs to be processed so the information that it contains can be available and measurable. In this paper, the Principal Components Analysis (PCA) is being implemented to localize and extract pathology existed on planar walls of heritage buildings. PCA is a statistical procedure of identifying patterns in data. Also, it is being used to analyze data through dimensionality reduction and thus extracting information which is not immediately obvious. The building that was selected for the pathology localization is the GaziEvren

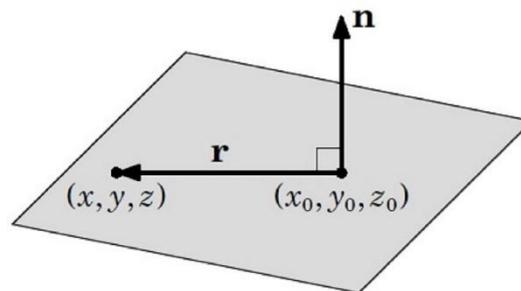
A normal vector of a plane is the geometric entity that specifies the orientation of the plane. If P is a plane in space R^3 and $P_0 = (x_0, y_0, z_0)$ a point on that plane, then the non-zero vector $\mathbf{n} = (a, b, c)$ which is vertical to P it is called normal vector (Fig. 1). For a random point (x, y, z) on plane P , the vector $\mathbf{r} = (x - x_0, y - y_0, z - z_0)$ is also on plane P and $\mathbf{n} \cdot \mathbf{r} = 0$ [6].

Fig. 1. Normal vector on plane at point $P_0 = (x_0, y_0, z_0)$ [6]

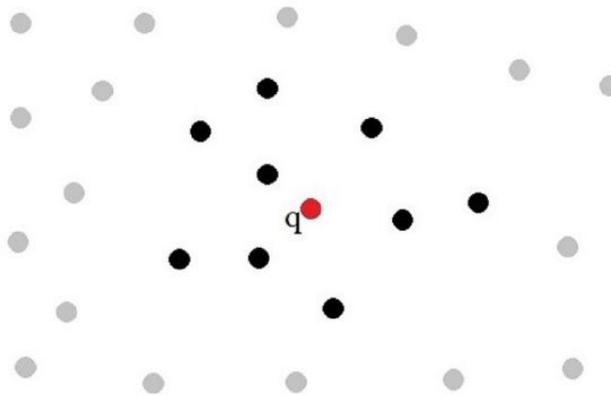
It is clear that the choice of the number k depends on the data that the users have at their disposal. If the number of the neighbors is n, then the number of the available points to adapt a planar surface and estimate its normal vector is n+1 (including the point for which the neighbors have been found) (Fig. 2).

Fig. 2. k nearest neighbors of point q. In this case, k=9 and the available points for normal vector estimation is 10.

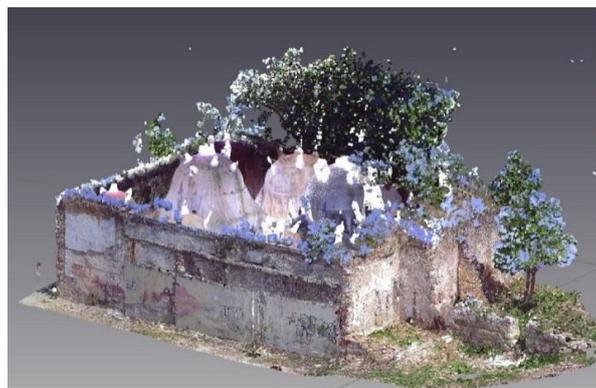
The tests of the pathology detection algorithm made for wall parts of the GaziEvrenos Baths. The GaziEvrenos Baths are located at the Greek city of Giannitsa and the 3D data that have been collected are part of the geometric documentation for the restoration proposal of the monument. The laser scanner that was used is the Faro Focus 3D S120. The clouds that have been measured were taken from 29 stations of the instrument, 15 for the exterior and 14 for the interior of the building (Fig. 3).

Fig. 3. Point cloud of GaziEvrenos Baths at the Greek city of Giannitsa.

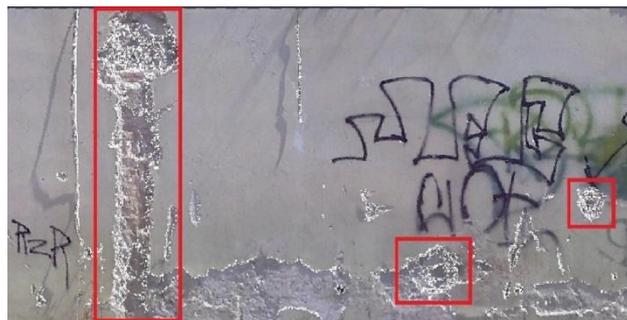
The algorithm was operated for various point clouds of the monument's walls. The tests showed that it is very important to choose the appropriate values of the parameters k and "coef". Table I shows the number of points estimated as pathology for part of the southeast façade of the building(Fig. 4) using 3 different values for each one of these parameters. Value 1 attributed to parameter "coef" indicates the outline of pathology, without introducing significant noise, better than values 1.003 and 0.9 for all k groups of neighbors.

Fig. 4. Orthoimage of southeast façade. White spots highlight the outline of the pathology detected. The chosen combination of the parameters k and coef is 21 and 1 respectively.

At this locations there is important lack of material. If we go back to Fig. 4, these areas are being highlighted by the three red frames. The points within these frames are those estimated by the algorithm as pathology. Along the façade, in Fig. 4, there are also white points (pathology) that are not distinguished from the top view. These points are also pathology but not that important.

The dimensions of the area in Fig. 4 and Fig. 5 are approximately 6.536m x 2.171m. The part that will be chosen for the pathology estimation may be of smaller or bigger dimensions. It is up to the user and it depends on what are the needs of the application that will be completed.

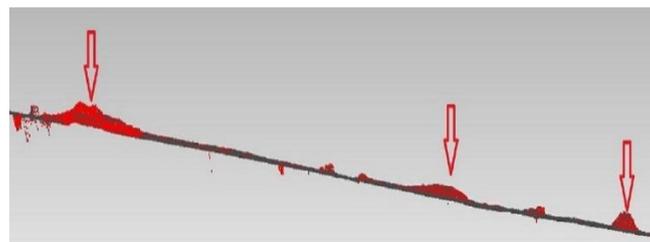
If we view this wall part from the top it is easy to locate three significant dents (red arrows at Fig. 5).

Fig. 5. Top view of southeast façade. Red arrows indicate the locations of cracks on the wall.

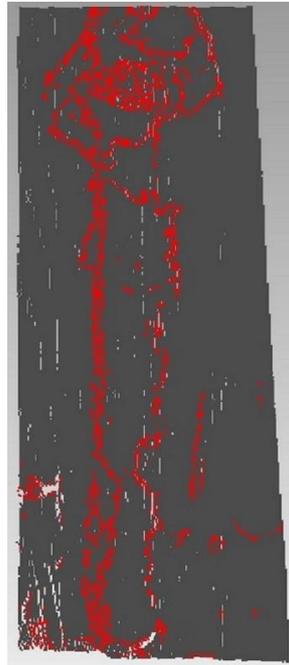
Fig. 6 shows a test that was completed, this time isolating the large red frame from the the wall shown at Fig. 4. In the case of Fig. 6, the combination of parameters k and “coef” that provide the most satisfying results is 31 and 1.003 respectively. The value and the results of coef =1.003 is very close to the recommended 1. Despite that fact, in other cases of point clouds and pathology the results are very different under these two scenarios.

Fig. 6. Detail from southeast façade. Isolated point cloud, the colored red points (7975 out of 54009) highlight the basic outlines of this wall part pathology.

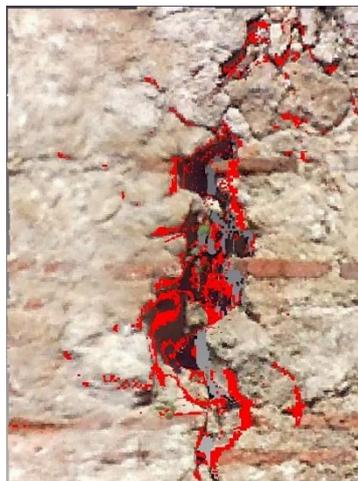
Another example from the exterior of the building is shown in Fig. 7. It is a part of the façade that the entrance to the building exists. In that case the main pathology consists of a big hole on the wall's material. The combination of the available values for k and “coef” that gave the best results is 31 and 0.9 respectively. The value 0.9 to the parameter “coef” made able to exclude from the pathology points a big amount of noise.

Fig. 7. Detail from main façade. Isolated point cloud, the colored red points (8412 out of 42809) highlight the basic outlines of this wall part pathology. Lack of monuments material.

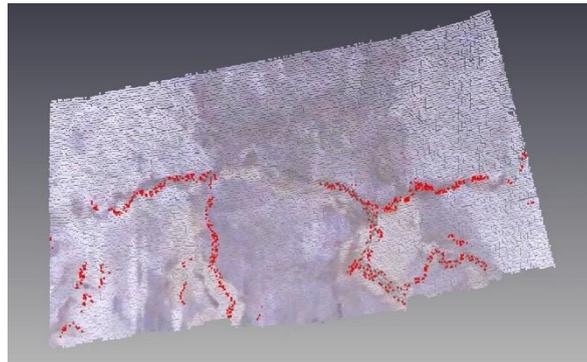
The most examples that are being introduced refer to the exterior of the GaziEvrenos Baths. This is why the most obvious and characteristic pathology existence is located on the building's façades. The last example of our algorithm implementation refers to the interior of the monument and is shown at Fig. 8. The values of the parameters are 31 to k and 1.2 to "coef".

Fig. 8. Detail from interior of the monument. Isolated point cloud, the colored red points (1532 out of 34322) highlight the outlines of the crack that exist on this wall part.
