Experimental Studies of Scour and Protection around Causeways

Abstract: Causeways also known as Rapta are the raised surface generally made of concrete laid on river bed across it, where river crosses the roads or highways. Whenever water flows over the causeway, it scours the upstream as well as downstream edges of the causeways leading to its structural failure. In this paper an attempt has been made to carry out extensive experimental studies on scour around the edges of the causeways on its upstream as well as downstream sides. Experiments have been carried out in 20m long, 0.74m wide and 0.60m deep laboratory flume. Models of Rapta were constructed by concrete blocks in 0.20m width with overall depth changing from 0.06m to 0.23m. A constant discharge of 1l/s was passed over the causeway maintaining a constant velocity of 0.135m/s and Froude No. as 0.379. Data of scour depths have been collected on predetermined nodal points along the edges of the causeways with time varying from one hour to 24 hours. The results of scour are presented in the form of graphs. Also, methods have been suggested for its mitigation.

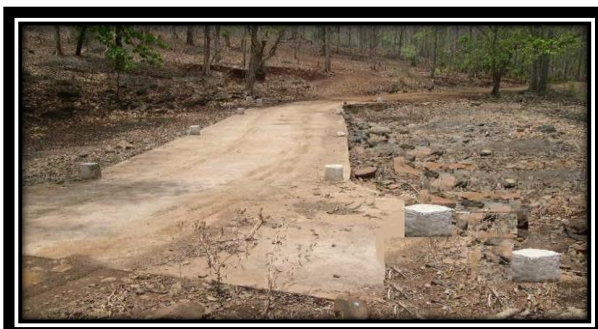
Garouti -Tindwari Causeway, Dist. Banda, U.P (India)

Causeways (or Raptas) were constructed in ancient times by the people to save the enormous cost of construction of bridges and culverts at many locations where a single highway crosses many water bodies. The Traffic and cattle can easily cross the ever-flowing rivers at very low depths throughout the year. At very high flow (Monsoon flood), a Rapta may wash away or a subsidized. Few typical views of few causeways may be seen in Fig.1.

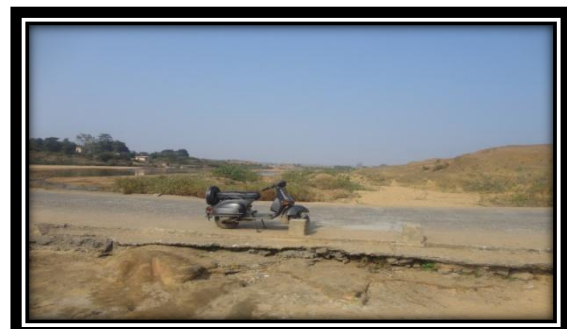
Kewai Causeway at River Kewai M.P (India)

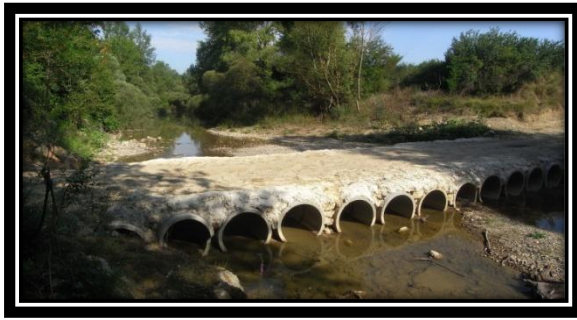
Vented Causeway at Feccia River(Italy)

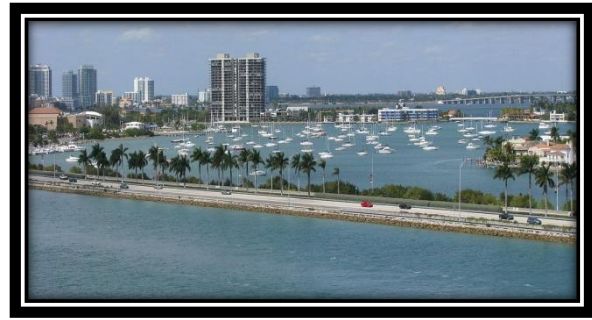
MacArthur Causeway, Miami Beach (Florida)

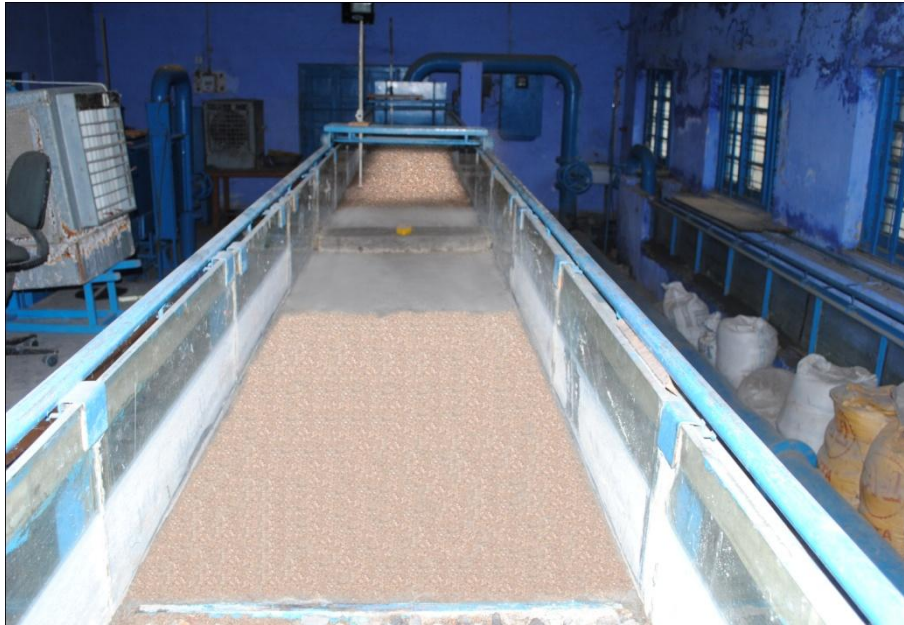
Fig2. Schematic View of Experimental Set-up

The experimental set-up (Fig.2) consists of a long rectangular flume (20m in length and 0.74 m width and overall depth as 0.60 m). The coarse sand was filled throughout the length of the flume to form the bed of the river. An overhead tank was used to supply water in to flume at the constant and required rate. Water was controlled by a regulating valve at the upstream side. At the inlet of the flume, its section is deepened in the form of deep rectangular tank to damp the turbulences and allow calm water to flow into the flume. Also, double grillage system made of bricks was used to further damp the turbulence. Similarly, at the downstream of the flume big boulders were used to stop flowing and unnecessary movement of sand after the scour takes place. About two third distance from the upstream the site was located where the pilot models of the proposed causeway are to be tested. To measure the scour both on upstream and downstream of the causeway, pointer having smaller circular strip at their bottom were used. The models of causeway (Fig.3) were first fabricated with reinforced cement concrete with known dimensions. The total length of causeways in each case was kept equal to width of the channel i.e. 0.74 m. The width is kept as 0.15 m and invariant till the end of the test. However, the depth was changed. The depths of concrete causeways varied from 6 to 23 cm.

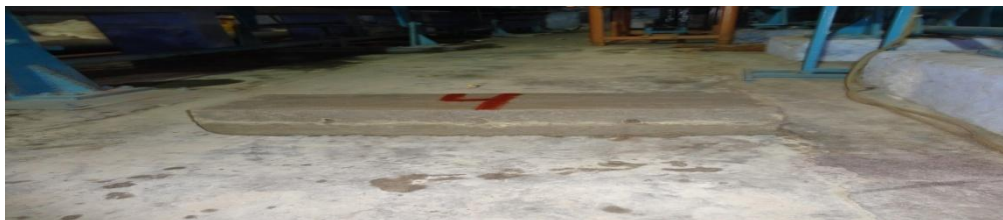
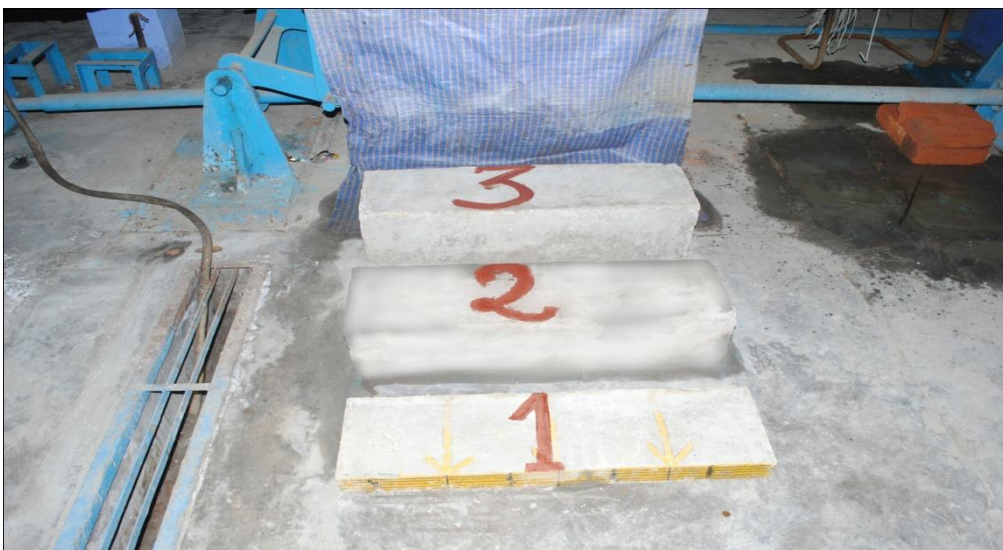
Fig3. Schematic view of Model Causeway Slabs used in present study

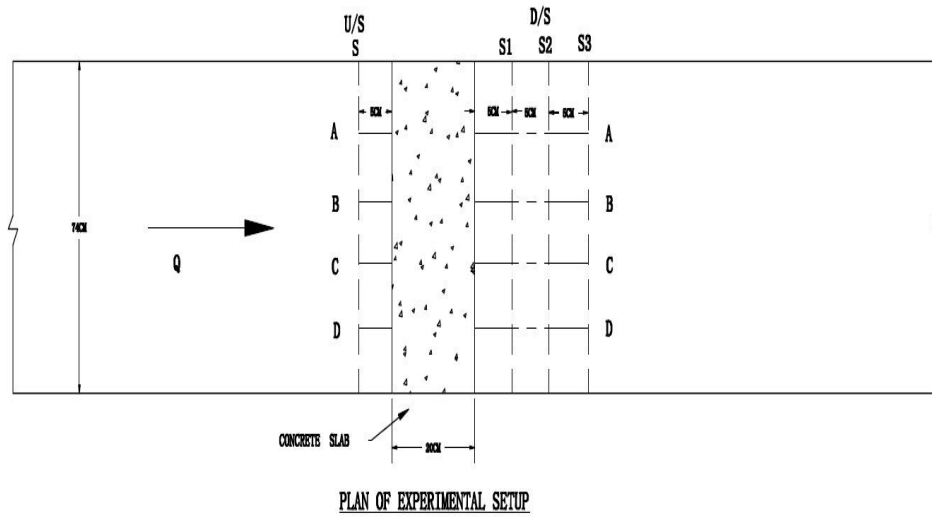
Fig4. Allocation of points to measure Scour u/s and D/s of Causeway

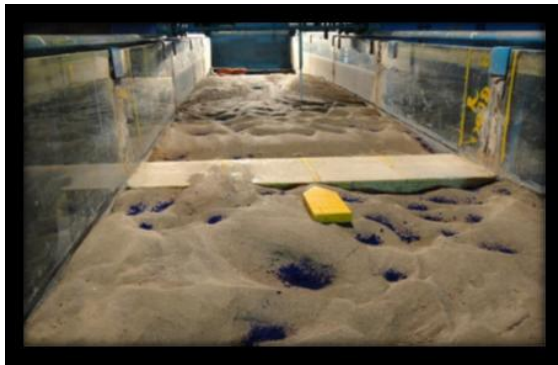
Causeway Depth 6 cm

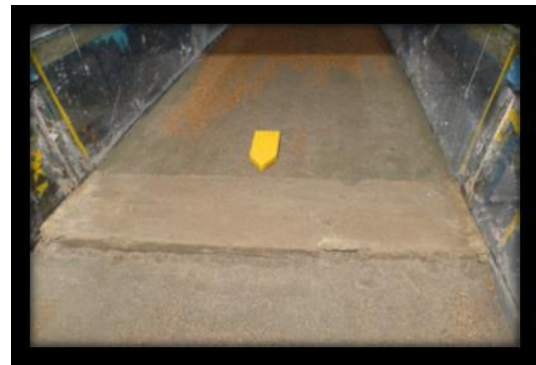
Causeway Depth 15 cm

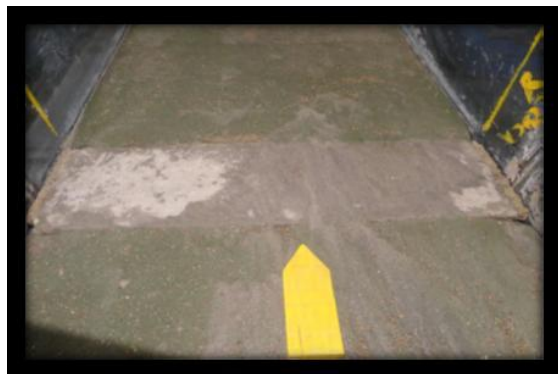
Causeway Depth 23 cm

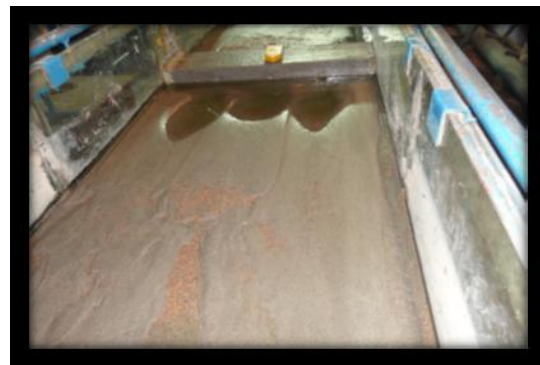
Special Causeway with three pipes

Scour study was also performed on special causeway where three Hume pipes were installed (Fig.5). Due to this, the scour at the upstream side is minimized but due to jet flow it is pronounced, causing scour at the points where the jet impinges the downstream bed. Scour depths were also measured with time and with space.

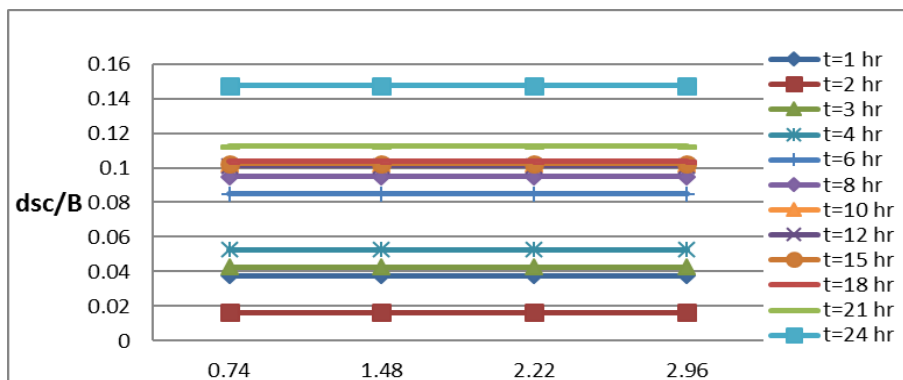
Fig6. Average Scour depth along causeway (D=6cm) u/s Location S

Figures 6 to 8 show the variation of dimensionless scour for causeway with 6 cm depth where run was taken continuously for 24 hours at fixed intervals of time. It is found that scour takes place on both sides of the causeway. Along the edges of the causeway on both sides scour is almost uniform as shown in all these figures. It is also clear that scour depends upon time. As time increases, scour at all predetermined locations, increases. This may be attributed to gradual removal of sediment particles continuously.

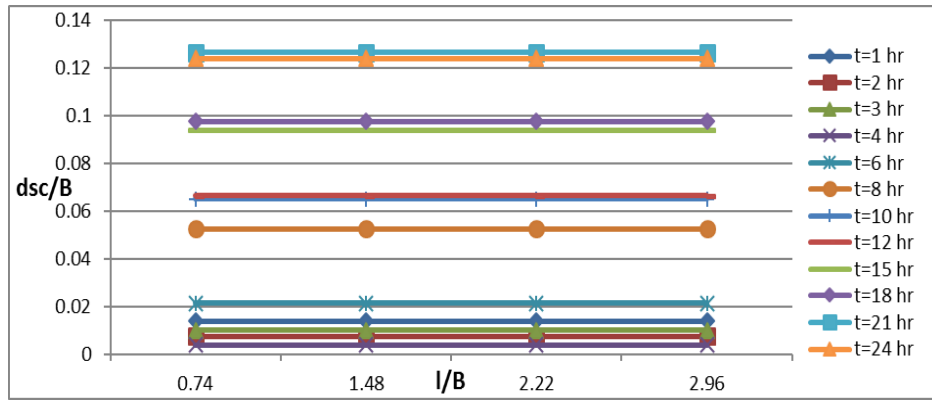
Fig7. Variation of average Scour depth along causeway ($D=6\text{cm}$) d/s S1

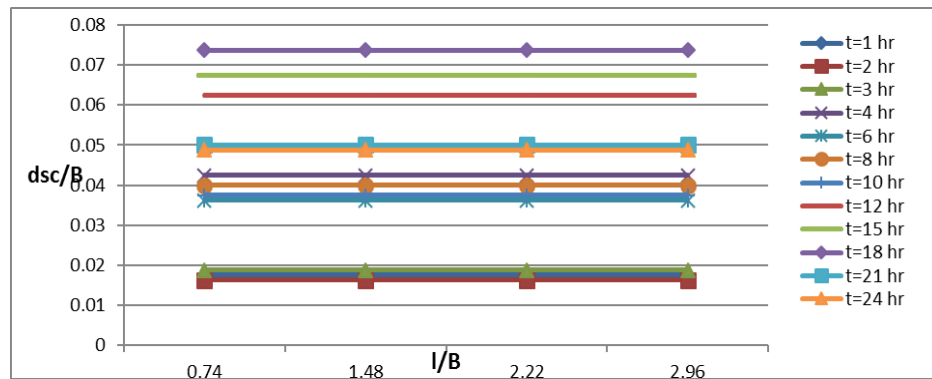
Fig8. Variation of average Scour depth along causeway ($D=6\text{cm}$) d/s S2

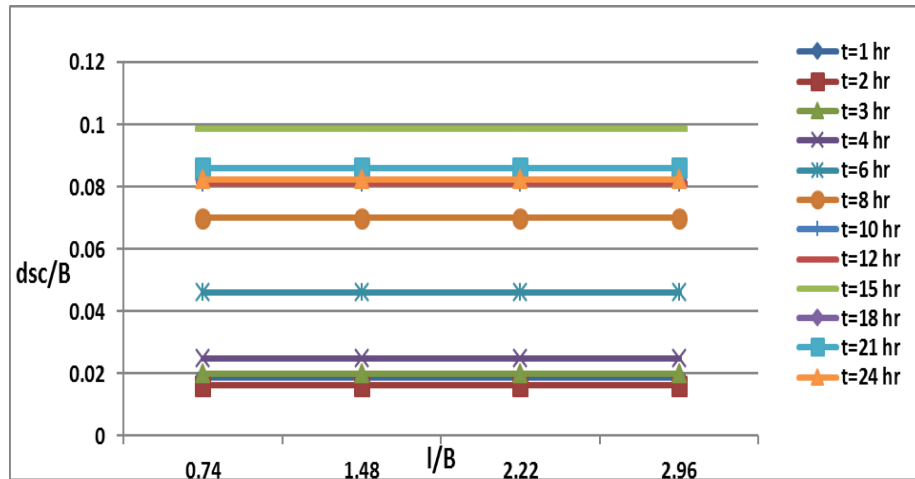
Fig9. Variation of average Scour depth along causeway ($D=6\text{cm}$) d/s S3

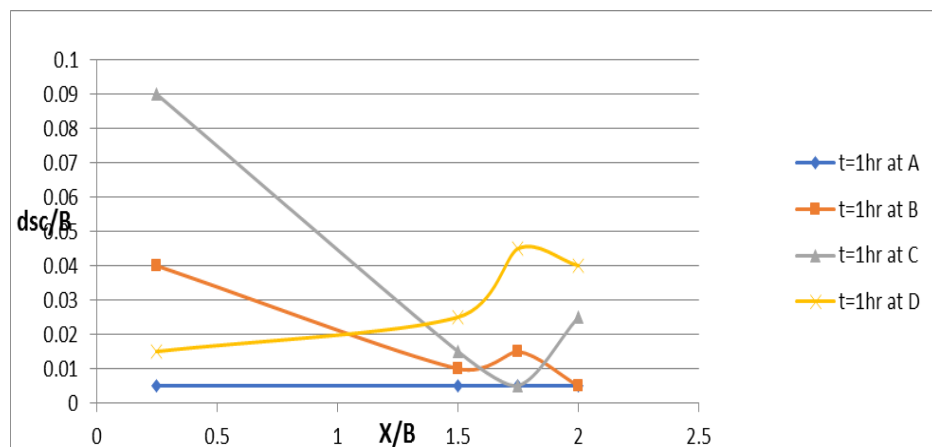
Fig10. Variation of Scour depth across causeway (along flow) for $D=6\text{cm}$

at Time t = one Hour

Figures 10 and 11 show the variation of scour across the causeway at predetermined points for one hour and 24 hours for same hydraulic conditions. The value of scour at u/s is comparatively higher than downstream values. It is clear from these plots that with time scour is varying but trend is not fixed. The possible reason may be that due to mobile boundary, the sand particles moving from upstream bed, might be filling the scour holes there by decreasing the value of scour and after some time, few particles may be leaving the holes due to shear stress developed at the boundary. The similar trends are obtained at the downstream side of the causeway.

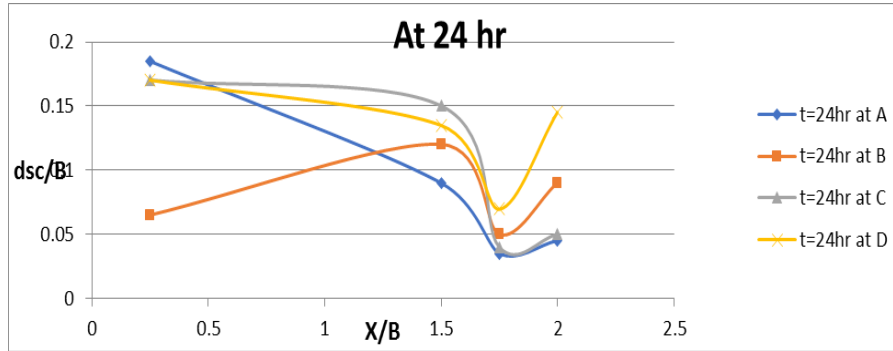
Fig10. Variation of Scour depth across causeway (along flow) for D=6cm.
