Identification and Visualization of Vegetation Encroachments along Power Line Corridors using LiDAR

One such technology, Light Detection and Ranging (LiDAR), was used to identify vegetation encroachments along several power line corridors located in a residential/commercial section of Callahan, FL, United States; just outside the city of Jacksonville. A semi-automatic process was used to generate LiDAR-derived conductor line vectors, on which a buffer algorithm was run. This resulted in LiDAR points being reclassified which were within a dangerous distance of the conductor vectors. These vegetation encroachment points were aggregated into polygon regions of vegetation to be removed, and the polygons were viewed over an imagery background in several applications.

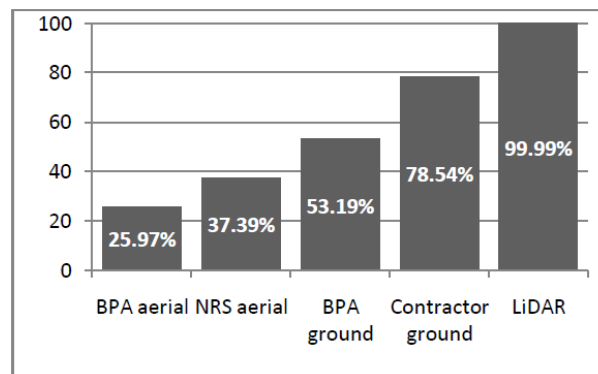
Figure2. Accuracy comparison of BPA’s inspection techniques

In the second study Bonneville Power Administration (BPA), a federal nonprofit agency based in the Pacific Northwest and part of the Department of Energy, five power line corridor vegetation inspection techniques were compared in order to critically evaluate vegetation management programs in place in the utility industry (Narolski, 2010). Inspection techniques included (1) ground inspection by BPA personnel, (2) helicopter survey by BPA personnel, (3) helicopter survey by natural resource specialists, (4) ground inspection by contracted private firm, and (5) LiDAR remote sensing (figure 2).

As determined by BPA, LiDAR outperformed all other field inspection techniques by locating the most clearance violations. This was true even after accounting for an approximate 12% rate of false positives found in verifying LiDAR reports in the field. These false positives were objects other than vegetation such as transmission line hardware, light poles, abandoned wood poles, and birds (Narolski, 2010). LiDAR stood out in this study because of the number of false negatives found in more subjective, human-based inspection methods. While the LiDAR approach located some false clearance issues, other methods missed real clearance issues.

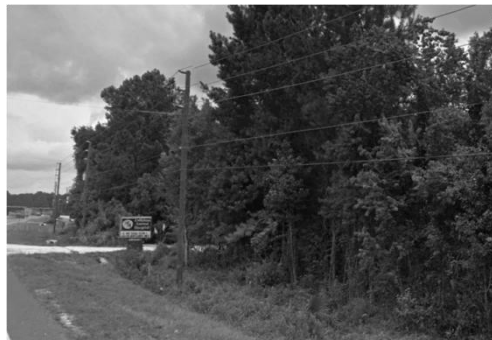
Figure4. Power lines in the study area

of Jacksonville (figure 3). These power lines are characteristic of those many would see while driving around town, perhaps to and from work or the grocery store (figure 4). Distribution lines, sometimes referred to as ‘feeder lines’ in the utility industry, distribute electricity from substations to businesses and residential neighborhoods. Figure 4 shows that it is immediately apparent there is vegetation growing in close proximity to power lines in the study area, but the distances between the two are not yet known.

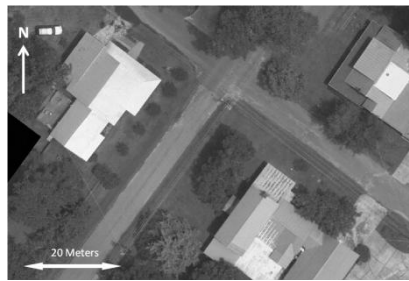
Figure8. A sample of the aerial image orthomosaic

Table2 shows metadata for the aerial image orthomosaic used in this study. Figure 8 shows a sample of the orthomosaic.

The aerial imagery originated as a series of separate images collected over the power line corridors in the study area at the same time as the LiDAR data. The data vendor processed the images to output an orthomosaic as a single enhanced compressed wavelet file. The high spatial resolution of the image allows the narrow conductors to be seen as a result.

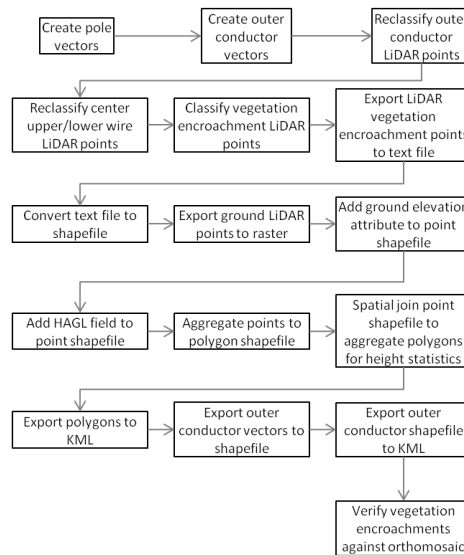
Figure9. The workflow used in this study

Figure 9 shows the workflow used in this study. The process starts with a LiDAR point cloud and ends with vegetation encroachment polygons and conductor vectors in shape file and KML formats.

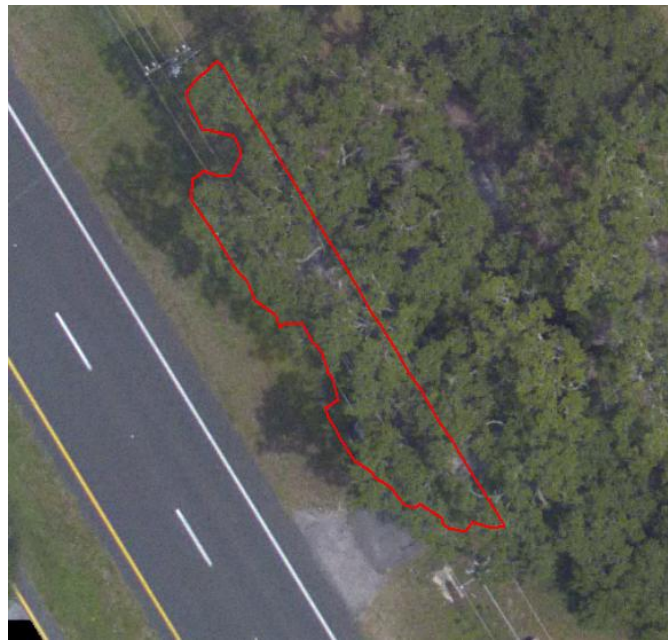
Figure22. *Vegetation inside a polygon obstructs the power line.*

The vegetation encroachment polygons were first viewed on top of the aerial image orthomosaic collected at the same time as the LiDAR data, in order to visually validate that encroachments exist where polygons indicate such a situation (figures 21, 22, and 23).

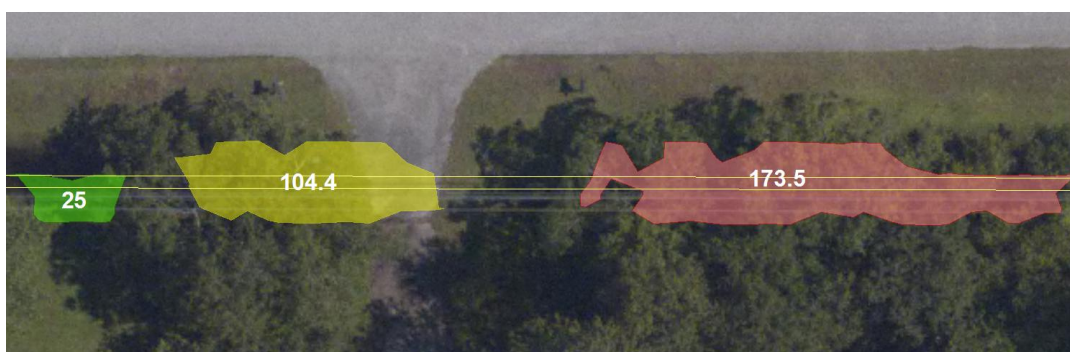
Figure24. *Vegetation encroachment polygons symbolized and labeled according to their areas in meters*

There are a variety of applications that can display and exploit the two formats of data produced in the previous section. This means the end user of the data need not purchase expensive software in order to fully take advantage of all the data has to offer. Of particular value are the attributes added to the vegetation encroachment polygons, which provide queues as to how much vegetation must be removed from a particular location and how tall the vegetation is. Figure 24 shows the vegetation encroachment polygons displayed in Arc Map labeled by the Shape_Area field. The polygons were categorized by area using a three class natural breaks classification, where green shows the group of smallest polygons, yellow the medium group, and red the group of largest polygons. The class groupings were 0.1 - 35 m², 35.1 – 137 m², and 137.1 – 475.4 m² respectively. The polygons could be labeled with any of the other attributes such as Min_AGL, Max_AGL, or Mean_AGL.

With the polygons labeled and symbolized by either area or one of the vegetation height attributes, planners of vegetation removal efforts can get a quick handle on what level of effort and cost would be associated with a particular project.

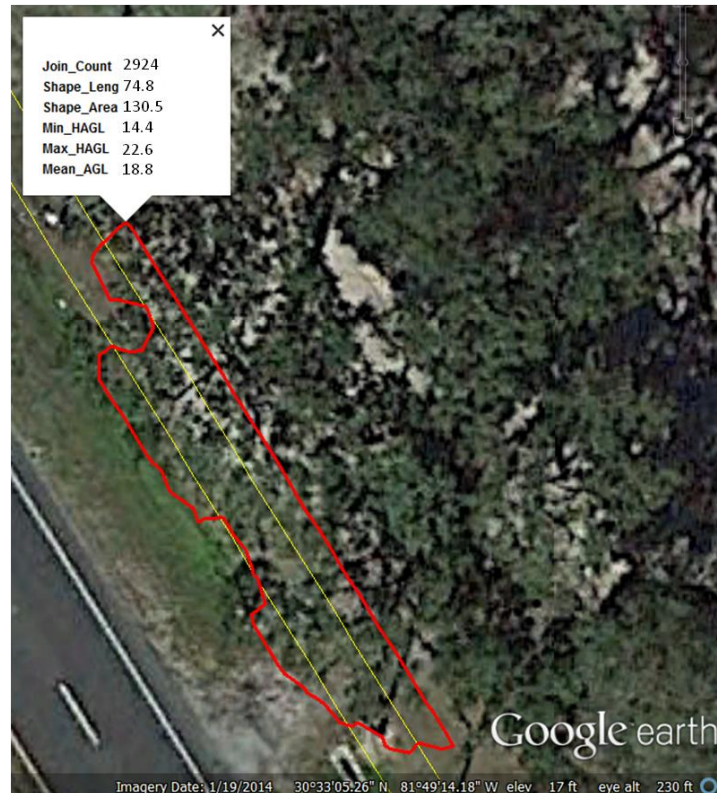
Figure25. A vegetation encroachment polygon displayed in Google Earth with HTML popup showing attributes

The same data in KML format can also be displayed in Google Earth, which anyone with an internet connection can obtain for free. In addition, the data user can view vector data over the seamless image orthomosaic provided by Google in the event no imagery was captured during a LiDAR mission (figure 25). Further, the Street View feature of Google Earth provides a unique way to visualize data. For instance, users of the data planning a vegetation removal effort can view encroachment and conductor data from the perspective of someone standing on the ground (figure 26). This is particularly useful for determining the feasibility of using specific equipment to remove vegetation, as the terrain or other obstructions could hinder removal efforts. The user has good situational awareness of removal sites without a visit to the field.

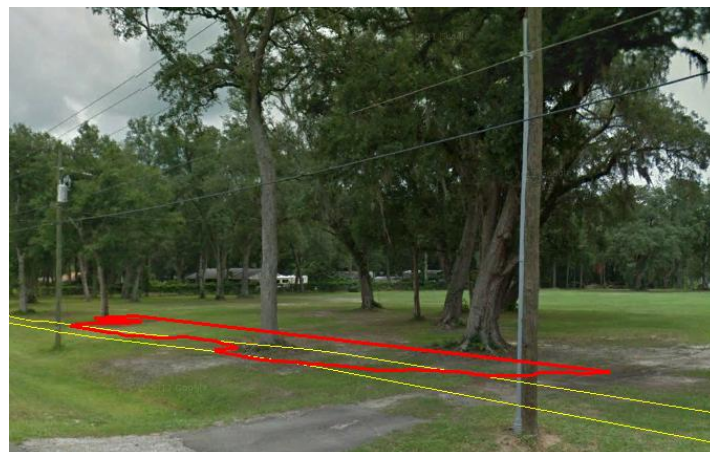
Figure26. A vegetation encroachment polygon displayed in Google Earth in Street View mode
